**DELTA VEHICLE
FLIGHT FAILURE REPORT
LAUNCH 33**

OCTOBER 1966

**GODDARD SPACE FLIGHT CENTER
GREENBELT, MARYLAND**

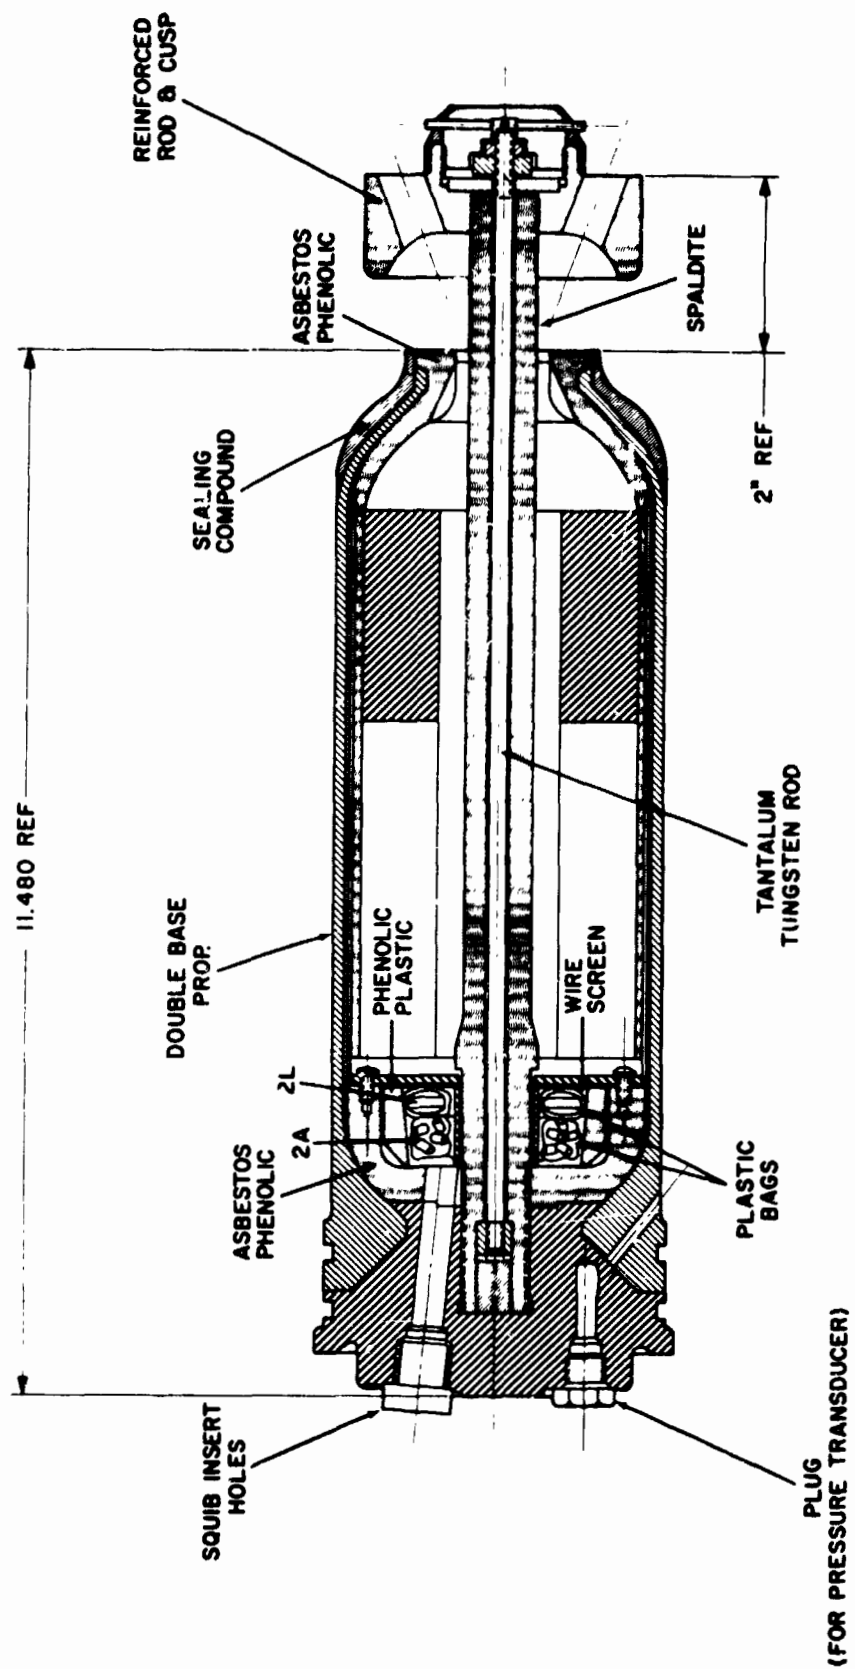
Figure 1

The pyrogen igniter used in Delta 33 (shown in Figure 1) was modified after the Delta 32 flight. This modification was made because a marginal ignition condition between the SD60AO squib and the BKNO_3 pellets, housed in the head cap of the igniter. This condition was discovered in a test firing at AEDC where an attempt to ignite the X-258 motor, with one squib instead of the customary two squibs, failed. The investigation of this failure revealed that the squib had discharged into the pellet chamber but the BKNO_3 pellets failed to ignite. The modifications made to the igniter to correct this marginal ignition condition were:

Since the modified igniter did not undergo spin acceleration tests, and since this was the first flight of the modified igniter, the possibility existed that in the process of modifying the igniter it was made sensitive to spin acceleration, impact, or static electric discharge and possibly upon spin up in flight the igniter fired without the aid of the squib.

- a. The use of two pellet bags in place of one. The bag material was 1 mil non-conducting polyethylene in lieu of the former 4 mil conducting polyethylene bag.
- b. Each bag contained different size pellets to improve the ignition characteristic. Pellet sizes 2A and 2L were used where only 2L was used in the past.
- c. A phenolic spacer of larger inside diameter was used instead of the styrofoam spacer to eliminate the possibility of blocking the squib port and also to make additional room available for the additional BKNO_3 .
- d. The metal screen separating the BKNO_3 pellets from the igniter propellant grain was redesigned and metal washers were placed under the retaining screws.

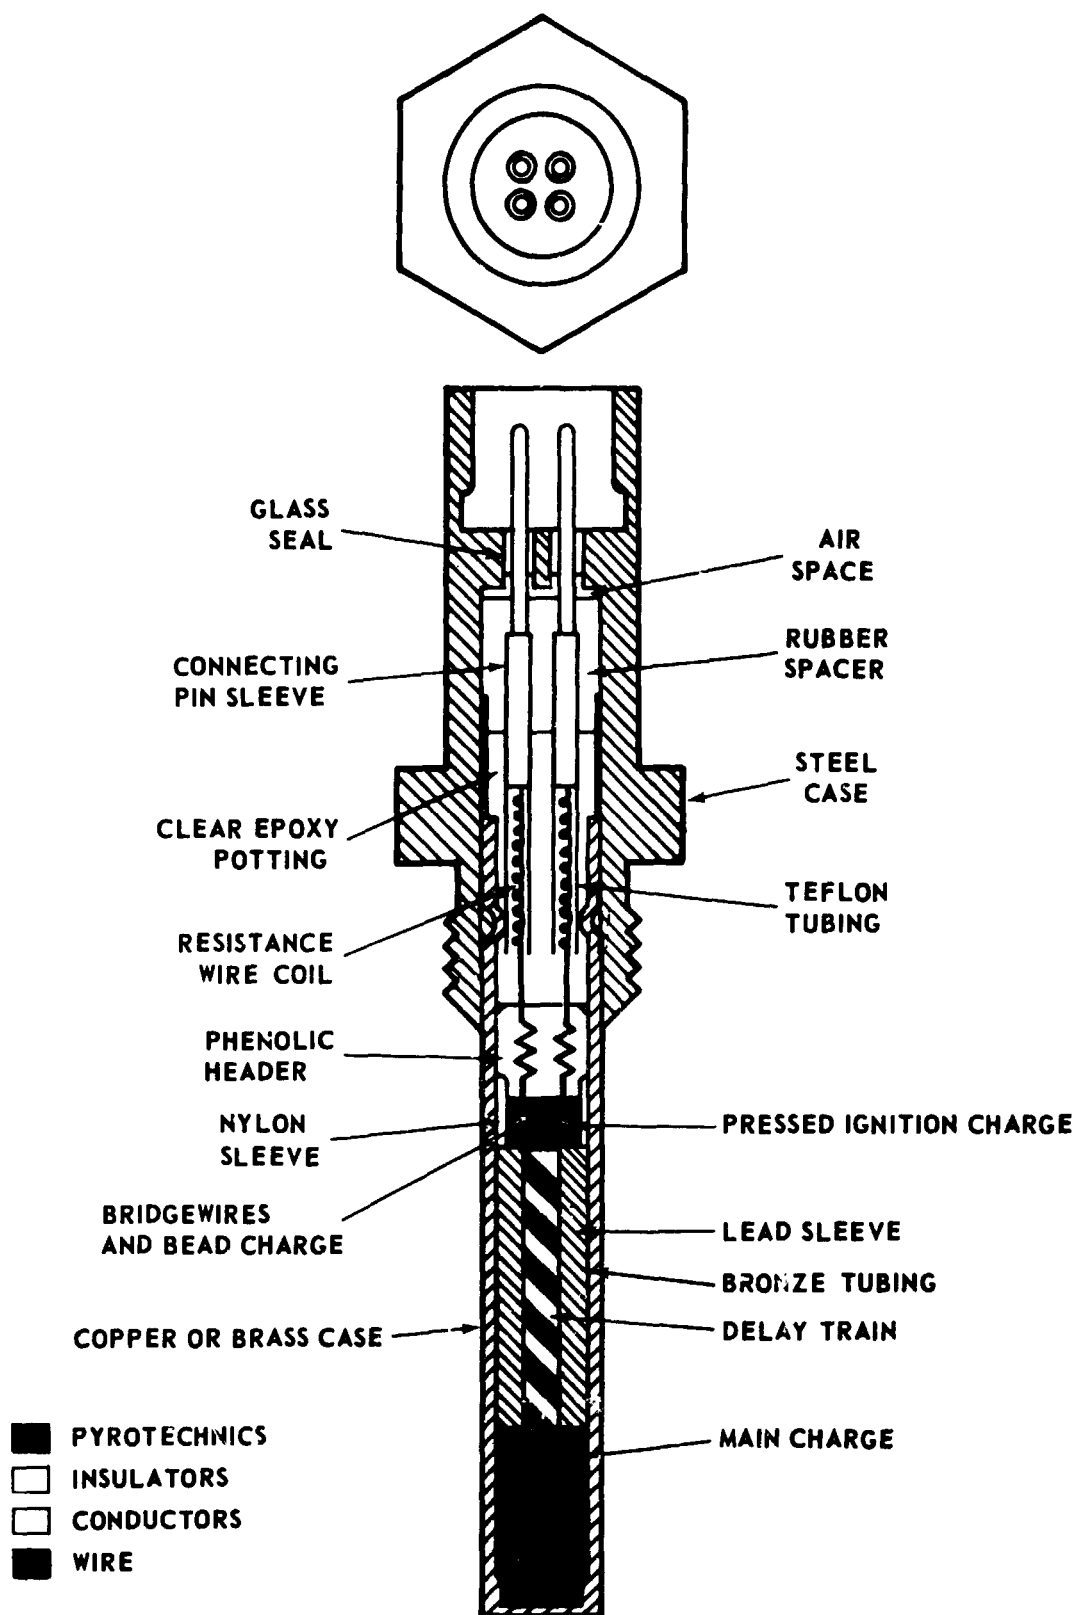
Figure 2-2D60A0 Squib Internal Construction

The SD60AO squib shown in Figure 2 contains a six second time delay train, dual bridgewires with a recommended all fire current of 5.0 amperes per bridge-wire. The bridgewires are covered with a single lead styphnate spot followed by a primer charge of 125 mg of lead oxide/boron which initiates the delay train composed of tellurium, selenium, and lead. The delay train fires the main charge

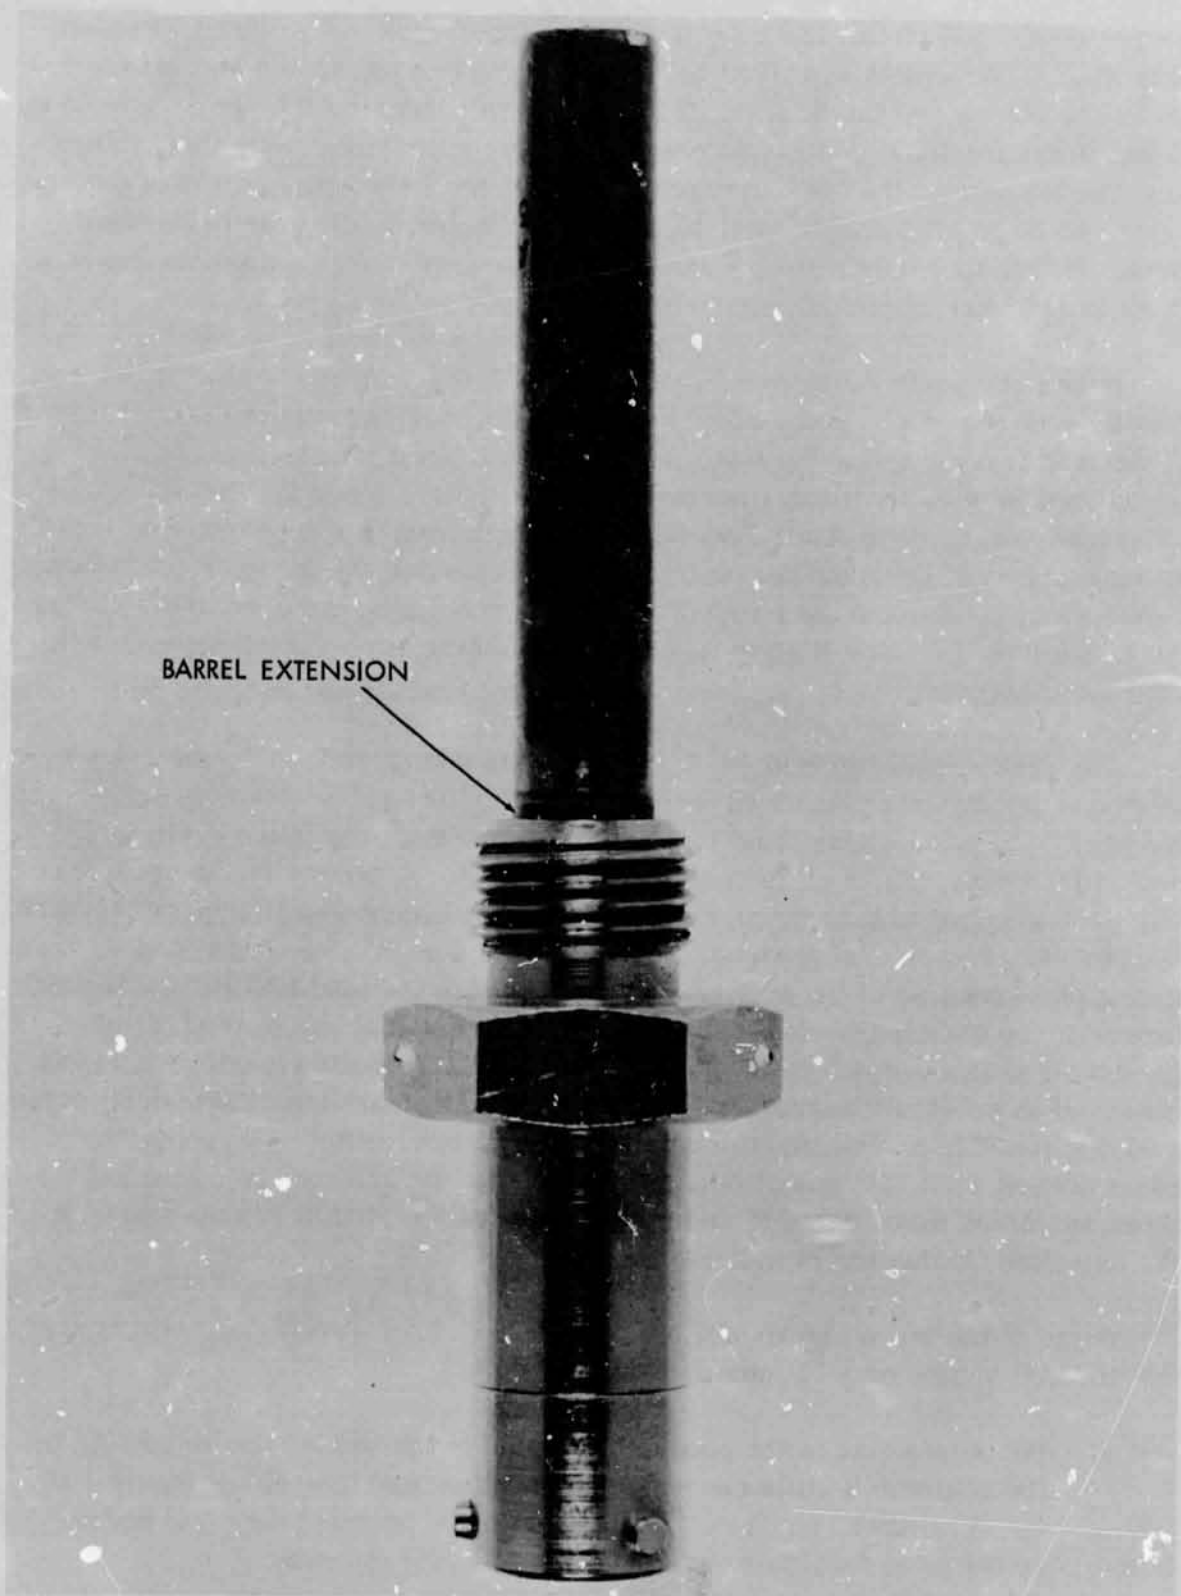
- a. Decomposition of the potting compound in the header due to heating by the resistance coils causes gas generation and internal pressure build-up. Pressure is relieved by "gas leakage" between the shell and header or barrel extension or in some cases barrel ejection.

Figure 4. SD60AO Showing Barrel Ejection

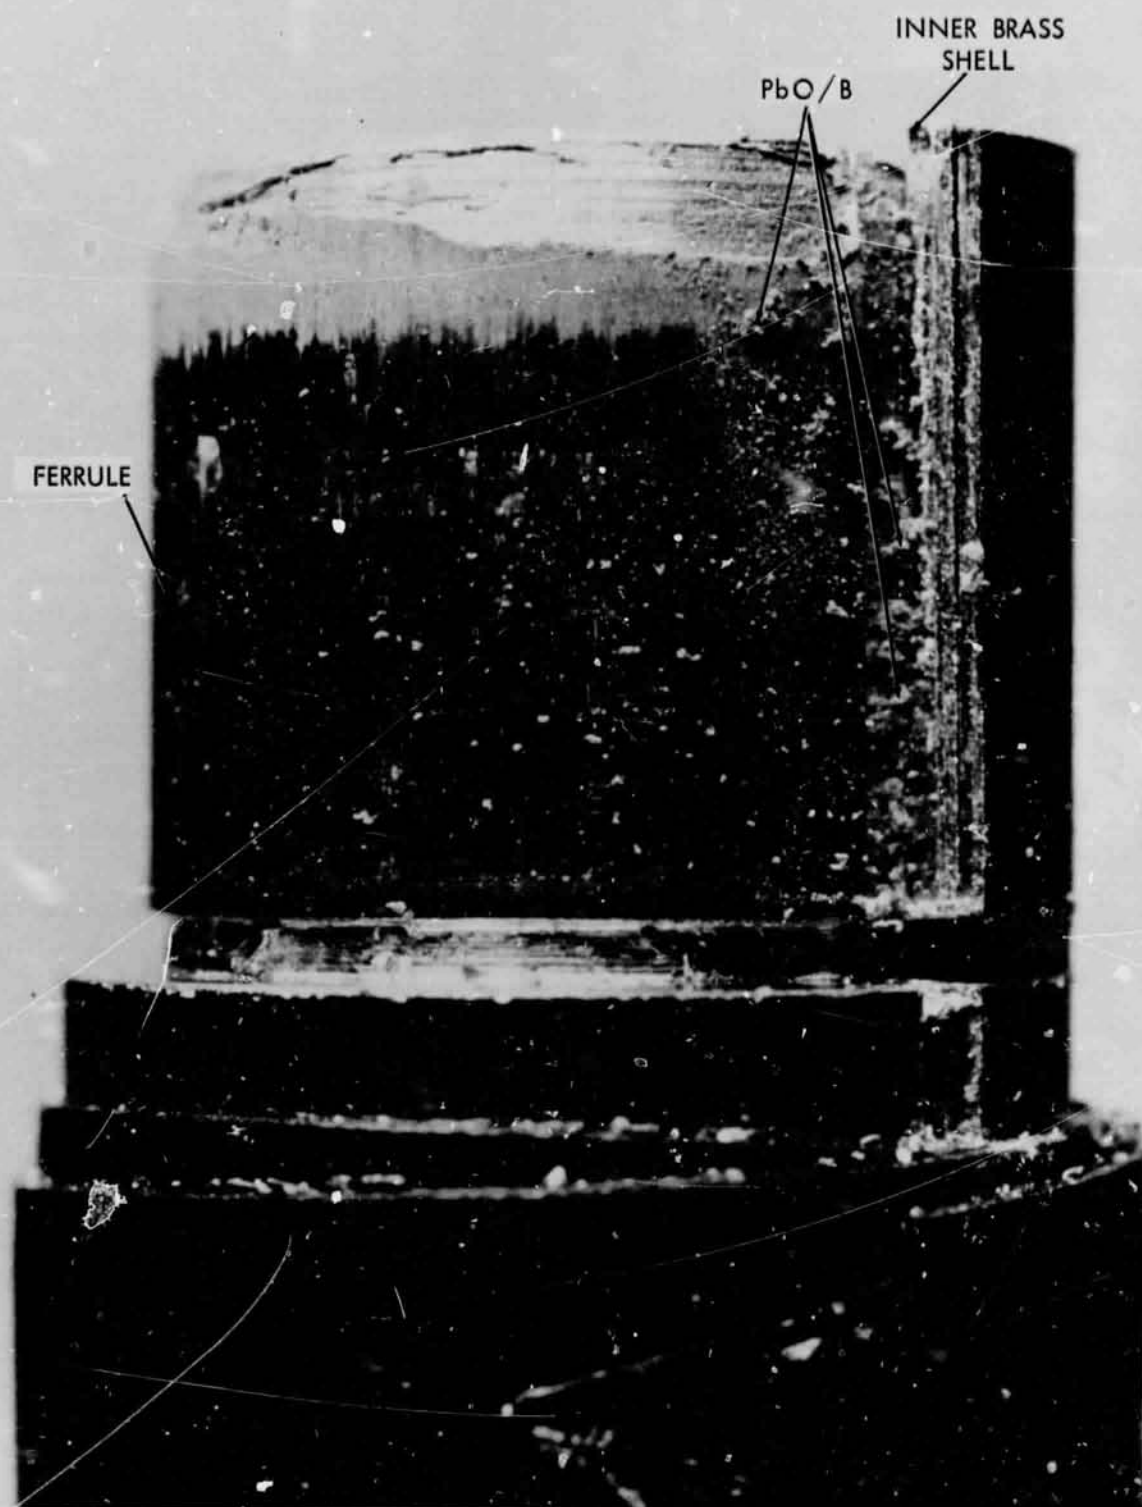
- b. Deposition of initiating and/or main charge (lead oxide/boron) material in some instances was observed between the lead ferrule containing the delay train and the brass shell (see Figure 7). Patches and globules have been observed extending from the main charge end up the length of the delay train and concentrated more heavily at both ends. Tests by Cornell indicate a gap greater than .005 inches is required for burning of this material. Gap widths greater than .005 inches are possible between the lead ferrule and the tubing due to fit tolerances, lead oxide/boron deposition and expansion due to temperature and pressure.

The most probable cause of the premature ignition of the X-258 rocket motor and the mission failure was the malfunction of the SD60AO squib. The most probable failure mode of the squib is for the initiation charge to bypass the delay train through a gap between the lead ferrule and the innermost brass shell.

Figure 7. Material Deposition on Lead Ferrule

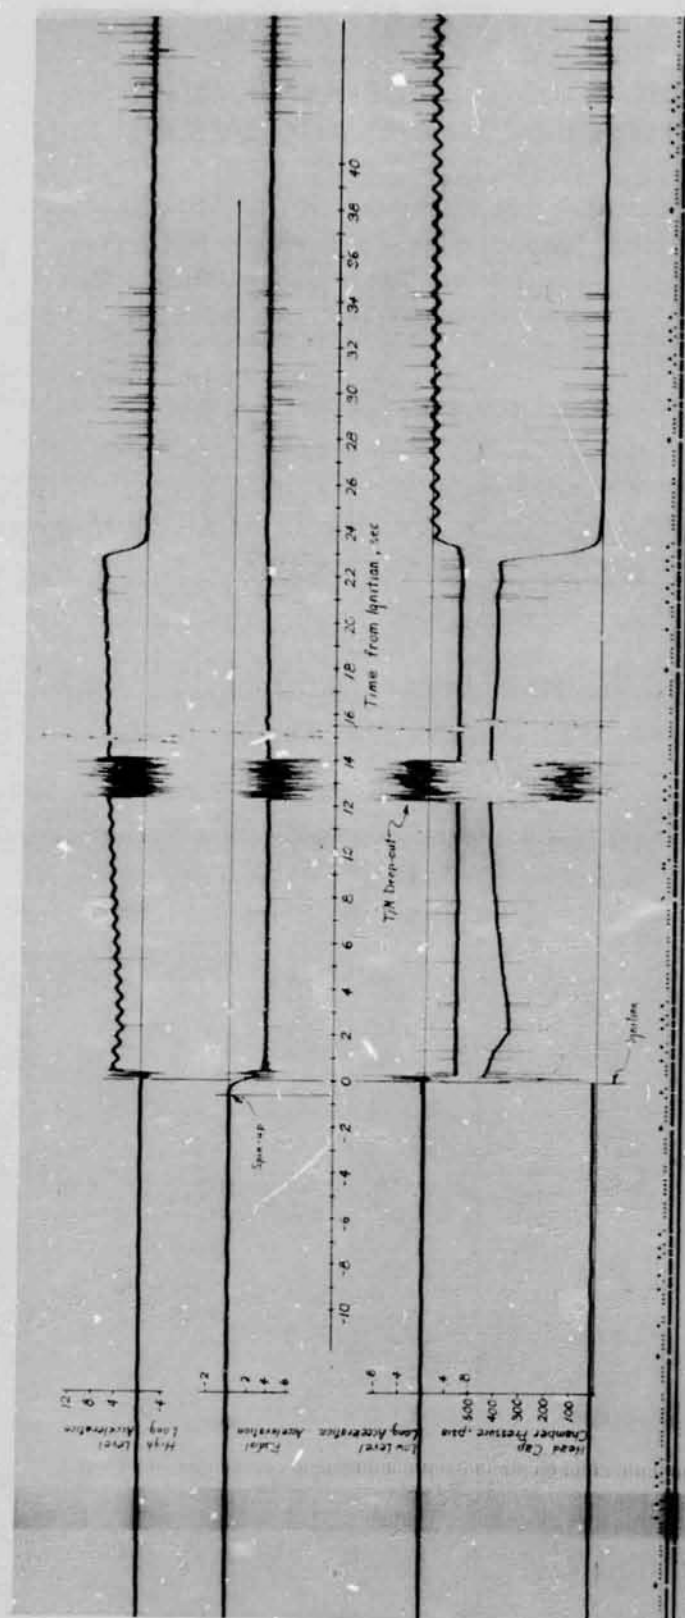
Expanded records of the chamber pressure shown in Figure A-4 were integrated by means of a planimeter over the time interval from ignition to apparent zero pressure. The pressure-time integral obtained by this method is 9,561 PSIA-Sec. Multiplying by an average $C_F A_T$ of 14.5 yields a total impulse of 138,645. This is slightly less than the expected for this motor however the discrepancy can most probably be attributed to overall accuracy of the T/M system and the method of data reduction. The chamber pressure trace indicates that the motor burned to completion with no unusual events occurring after separation.

Expanded records of the high range longitudinal acceleration shown in Figure A-4 were integrated by means of a planimeter over the time interval from ignition to apparent zero acceleration. The acceleration-time integral obtained is 3,758 ft/sec. which is 18% less than the predicted of 4559 ft/sec. This apparent decrease in performance was probably caused from (a) damage to the X-258 nozzle during separation which would result in a decrease in specific impulse realized and (b) the possibility that parts of the spin table remained attached to the aft end of the motor resulting in an increase in effective payload weight. The acceleration trace indicates large amplitude coning starting at separation and damping out during burning of the motor. This coning is probably caused from from the abnormal second to third stage separation experienced on this mission.

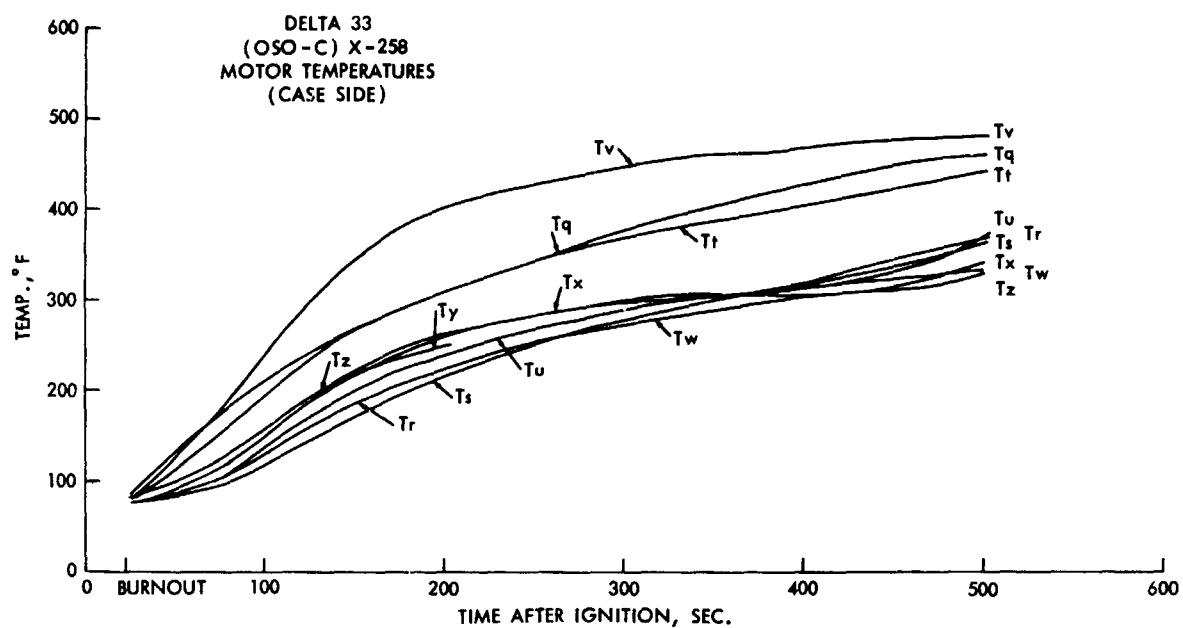
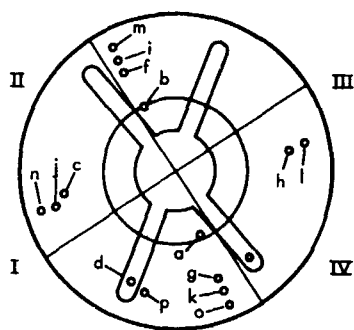
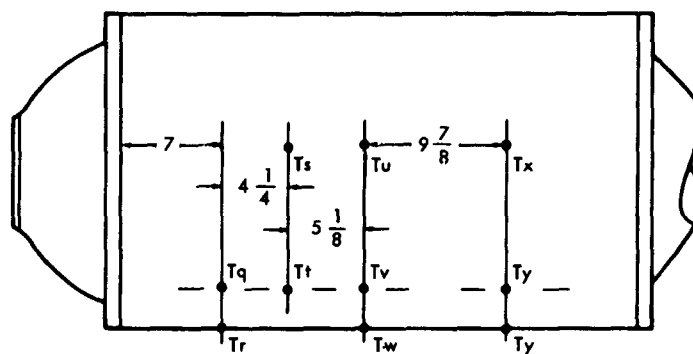
Figure A-5

Temperature data received from the ten sensors located on the side of the X-258 motor case indicate a maximum temperature of 475°F at 500 seconds after motor ignition. This is the first time the case temperature has been measured on an X-258-C4 motor and indicates the effectiveness of the added chamber insulation. The motor case was completely covered with aluminum foil which makes this test the most severe thermal condition the motor will be subjected to in flight. Past data indicates that the addition of aluminum foil to the outside of the case will increase the maximum case temperature by approximately 100°F. Figures A-5 and A-6 are temperature-time plots of the case temperature.

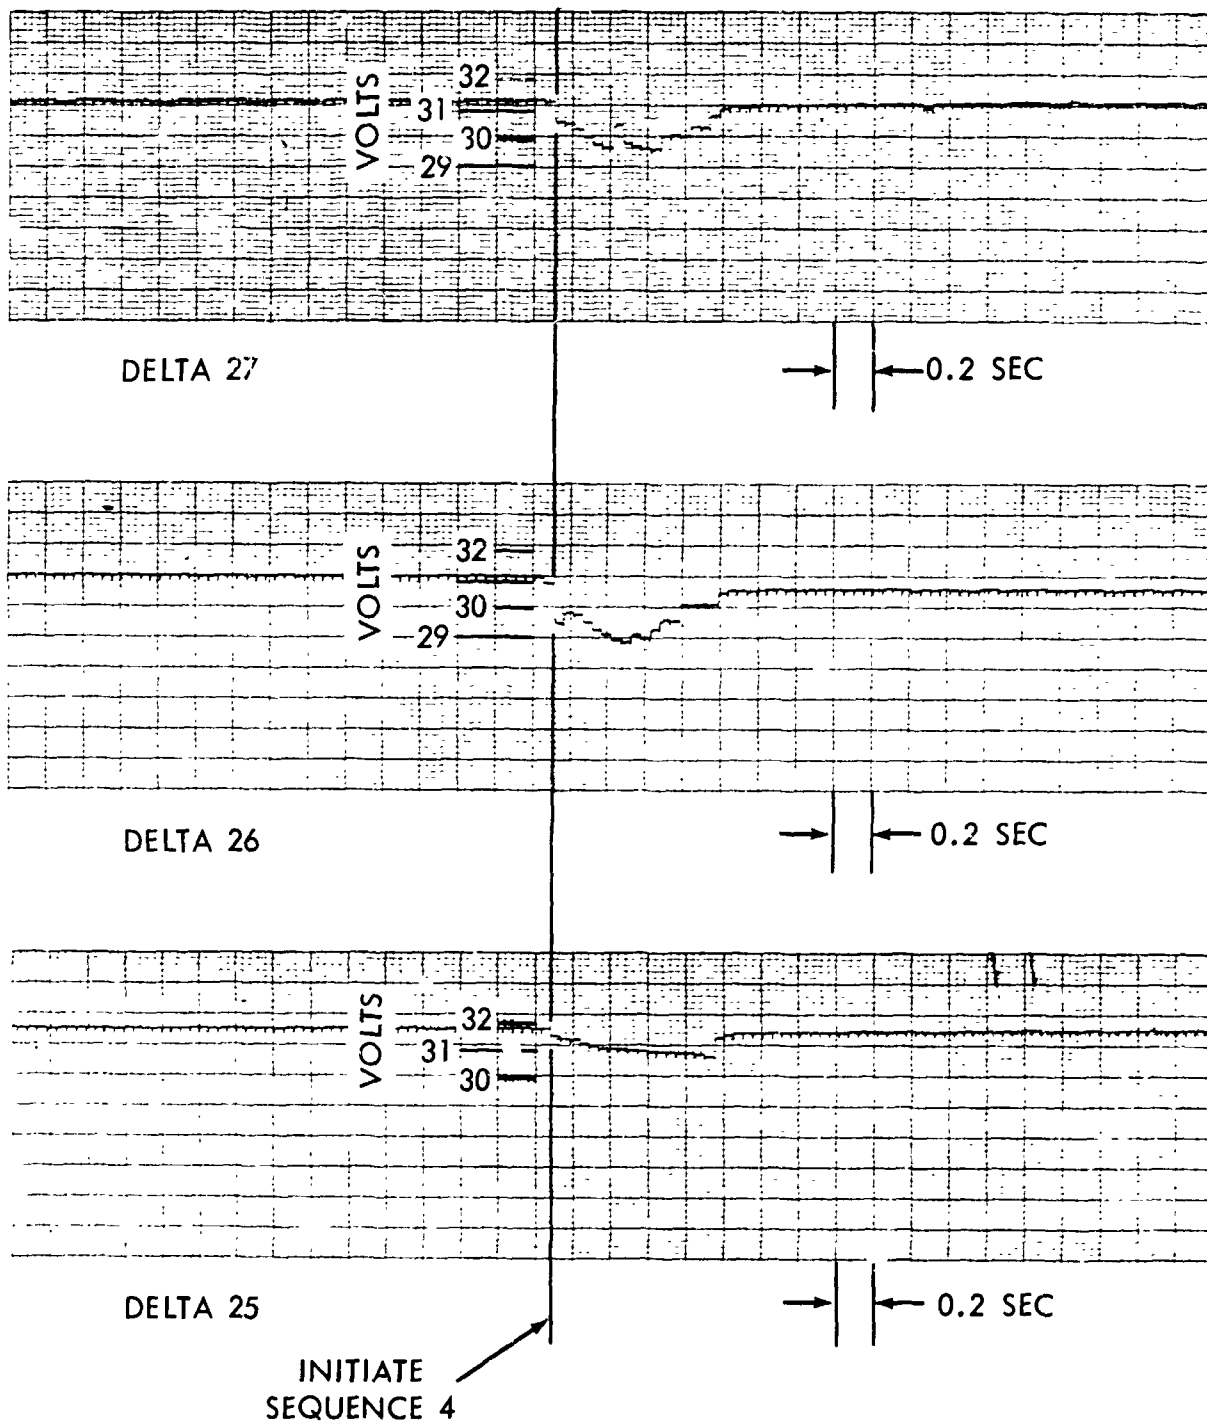
Figure C-7. Engine Battery Voltage at Sequence 4, Delta 25, 26, and 27

Referring to Figure C-7 they are the Delta 25 class and the Delta 26 class. Past flights which fall into the Delta 25 class are Deltas 29, 30, 31, and 25. The remainder are classed with Delta 26, except Delta 28 which appears to be a combination of both 25 and 26. The initial voltage drop, observed in Delta 33 and the Delta 26 class, was not observed in the Delta 25 class probably due to the sampling period of the TM system. The stepwise increase in voltage at 1 second after sequence 4, clearly apparent in the Delta 25 class, is not so clearly visible in the Delta 26 class. The differences may be due only to the random load caused by the spent bridgewire. Specifically, any shorted bridge wires may be "burned clear" prior to the 1 second time so that there was less load to be removed by the explosive switches (S1200/1201). In the records examined, the battery voltage had returned to normal at the end of the 1 second period, indicating that all load was removed by this time.

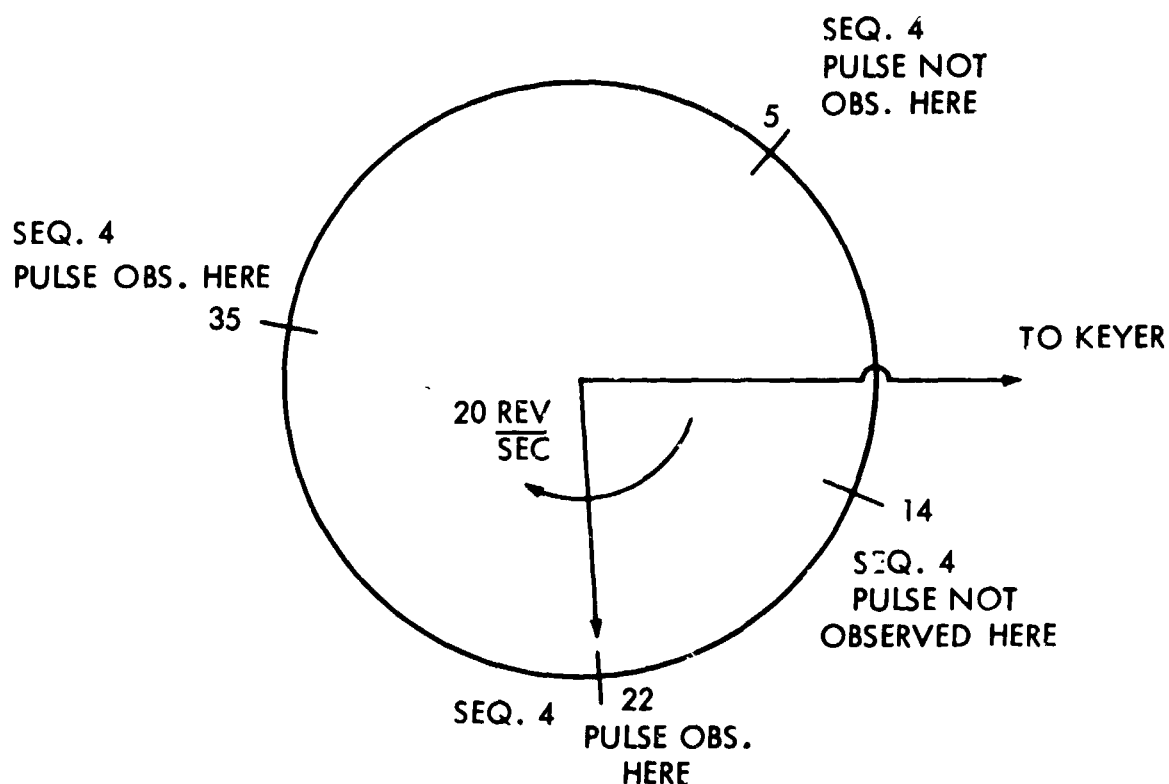
1. MINIMUM DURATION OF PULSE - THROUGH 13 CHANNELS @ $1.1 \text{ ms} = 14 \text{ ms}$
2. MAXIMUM DURATION OF PULSE - (JUST AFTER CH. 14 TO JUST BEFORE CH. 5) = 40 ms

commutator. Channels 5, 14, 22, and 35 derive their input signal from the engine battery. The initial pulse was observed on channels 22 and 35, but not on 14 and 5. Therefore, the duration of the pulse was between 14 and 40 milliseconds. Further, because of the distribution of the channels around the commutator, a pulse with a duration of 17 milliseconds or more would be observable by the TM system.

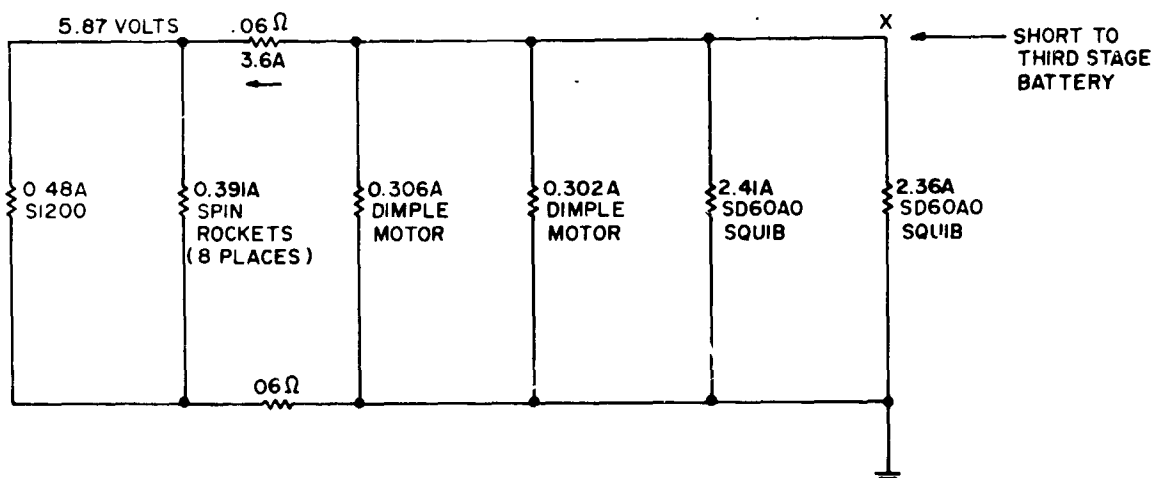
A third phase in the examination of the electrical system was the distribution of current if the third stage battery should short to the sequence 4 circuit at some point on the attach fitting. The results are shown in Figure C-17, and indicate this to be an unlikely failure mode. The third stage schematic is provided as Figure C-18.

Figure C-17. Sequence 4 Current Distribution — Third Stage Short
